GENEVA STATION LEVEL CROSSING COLLISION BOARD OF INQUIRY REPORT			
OPERATOR		PASSENGER RAIL AGENCY OF SOUTH AFRICA (PRASA)	
PERMIT NUMBER		ASP 0002 NTS	
INVESTIGATION SUBJECT		INVESTIGATION REPORT INTO THE LEVEL CROSSING COLLISION OF 04 JANUARY 2018 CLOSE TO GENEVA STATION INVOLVING A MAIN LINE PASSENGER SERVICES (TRAIN NUMBER 37012) AND A ARTICULATED TRUCK (REGISTRATION JCW 868 NW).	
DATE OF OCCURRENCE		04 JANUARY 2018	
REFERENCE NUMBER		RSR/20180104/002	
BOARD OF INQUIRY MEMBERS			
CHAIRPERSON	MR PHATUDI MAPONYA	MAPONYA INCORPORATED	
ELECTRICAL EXPERT	DR WILLEM SPRONG	GIBB	
ROLLING STOCK EXPERT	MR GIVEN MABASO	MJT CONSULTING	
HUMAN FACTORS EXPERT	MR MOSES SHABA	RAILWAY SAFETY REGULATOR

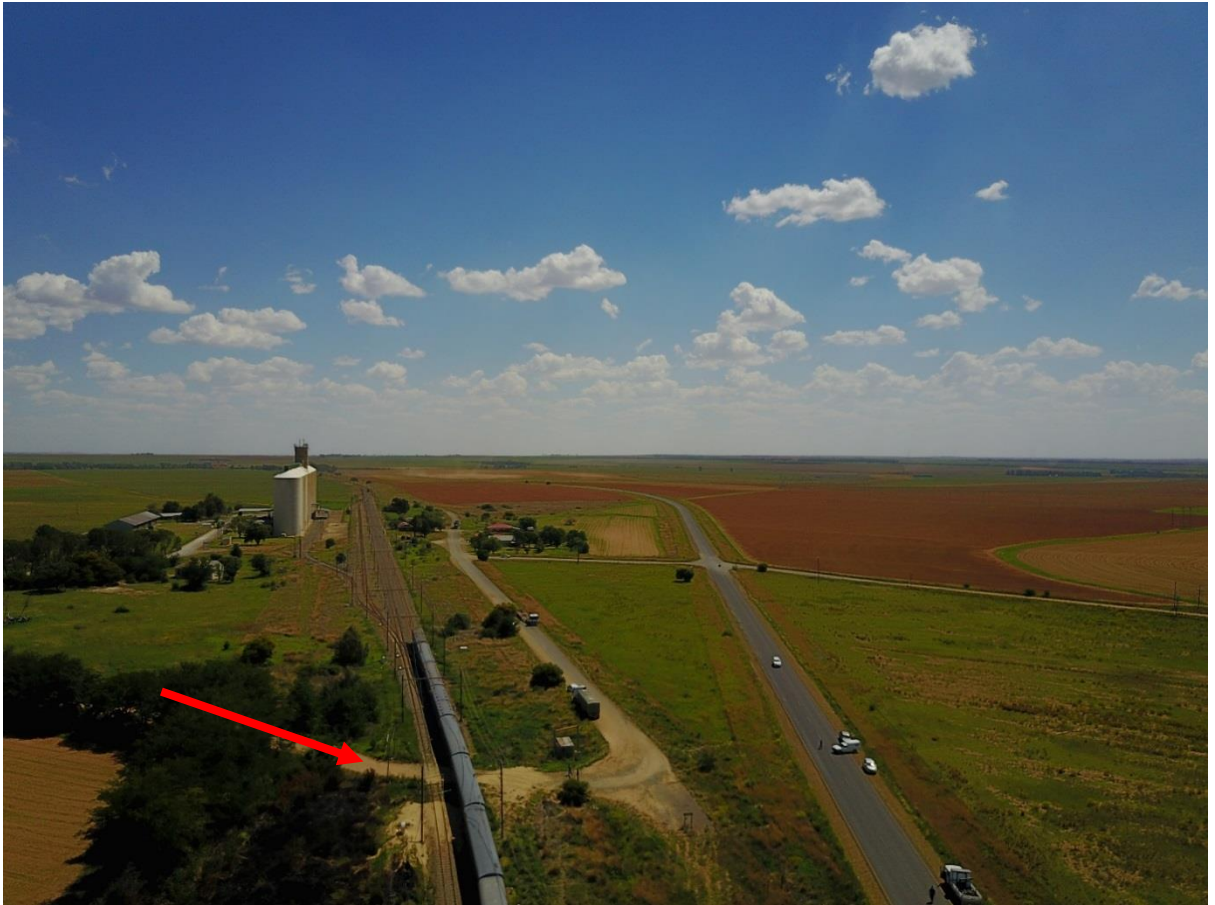
- 4.8 The aforementioned railway level crossing on the S175 road is situated 20km on the Henneman road from the Kroonstad station. The level crossing is located on a gravel road which is protected by advanced warning signs and a stop sign for any vehicle requiring to pass over. Figure 1 illustrates the direction of the truck as well as the compulsory stop sign just next to the end of the arrow indicating the direction.

Figure 1: Direction that the truck was traveling.

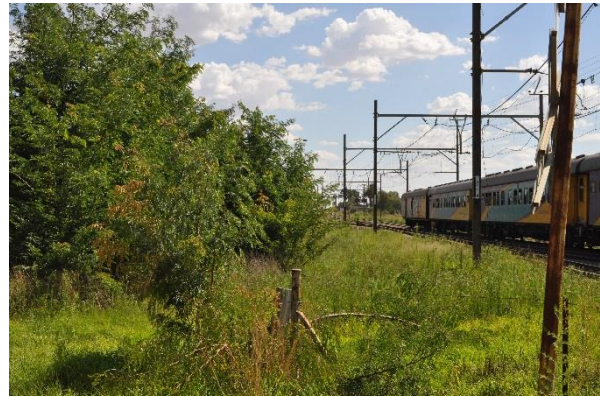
Figure 2: Stop sign on the approach to the level crossing

- 4.9.1 Around the vicinity of the level crossing, there was vegetation on both the left and right side of the road. The vegetation on the left side where the train was coming from covers around 100 meters towards the level crossing. Figure 2 also depicts the said vegetation.

- 4.9.2 Notwithstanding the fact that there was vegetation at the time of incident, the view at the compulsory “STOP” sign (which is within 5m from the railway crossing) was not obstructed. Therefore the truck driver’s visibility could not have been obstructed if he had stopped at the compulsory stop sign. Figure 2 also depicts the truck visibility from the stop sign.

- 6.7.5 At the level crossing, there was a compulsory stop sign which required the truck to stop. (See Figure 2 in Part D of this report).
- 6.7.6 There was also vegetation on both sides of the gravel road just before the level crossing. (See Figure 2 and Figure 3 in Part D of this report).
- 6.7.7 The vegetation identified at the level crossing, could have obstructed the visibility of the truck driver while approaching the crossing. His visibility was unobstructed at the compulsory stop sign. (See Figure 2 in Part D of this report).

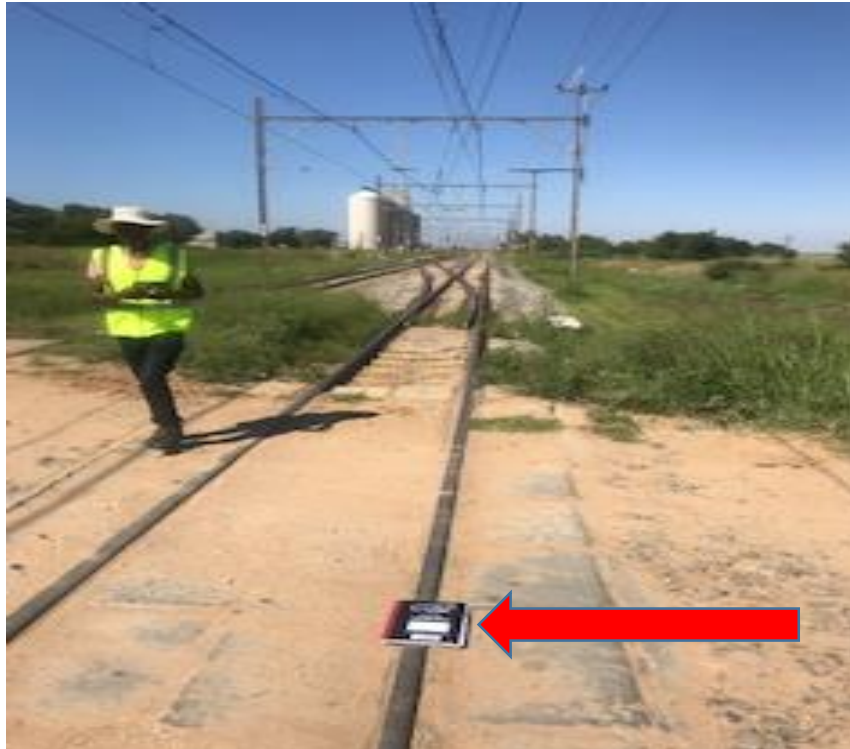
6.7.3 The place of incident is the Geneva double railway Level Crossing No. LX02265, at mast location 21/14.

Figure 13: This is the point of incident

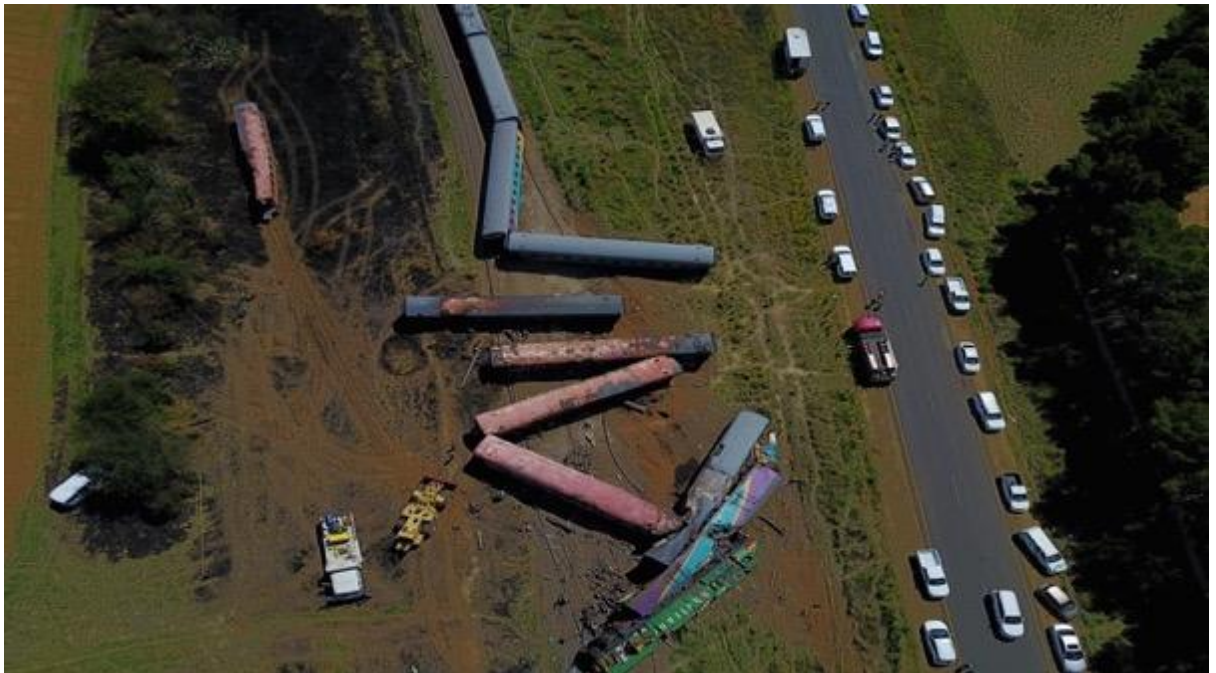
Figure 14: This is the aerial view of the point of incident

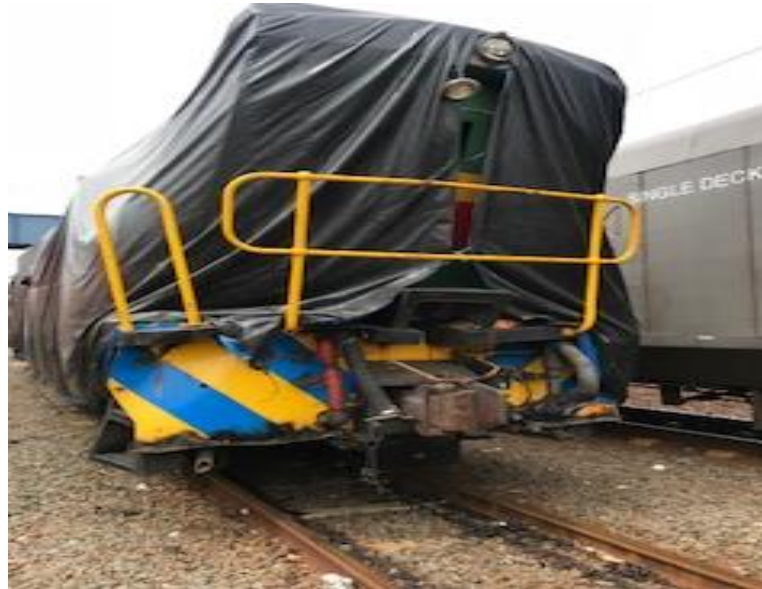
possible to properly inspect the body of the locomotive. It was only possible to inspect certain parts of the under frame which include bogies, wheels and brake blocks.

Figure 16: This is the locomotive covered at the time of the inspection
